FINAL REPORT
DEMONSTRATION OF 156 INCH MOTOR WITH
SEGMENTED FIBERGLASS CASE AND ABLATIVE NOZZLE

VOLUME II--STATIC TEST AND HYDROBURST (U)

December 1968

THIOKOL CHEMICAL CORPORATION
WASATCH DIVISION
Brigham City, Utah

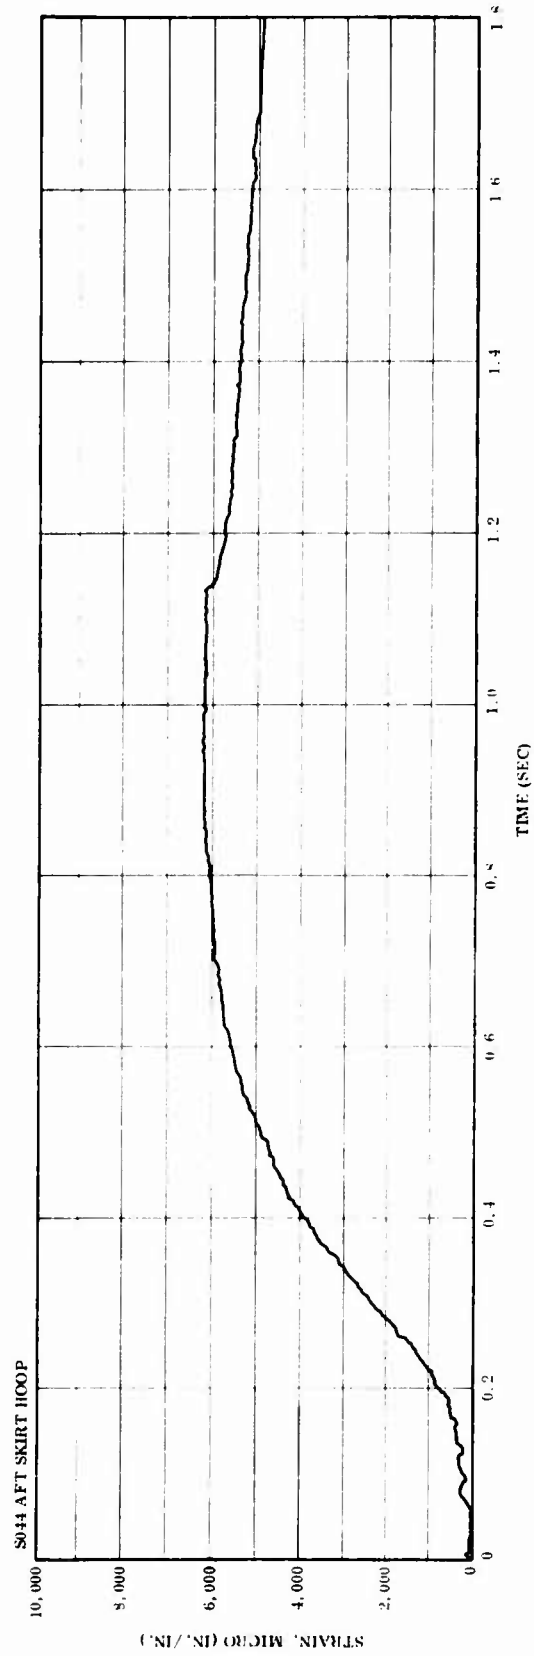
(U) During static test the repaired skirt supported the motor as intended but after firing it was noted that the 181E glass overwrap had failed. It developed five longitudinal cracks which were induced by hoop strain. The strain time trace indicated that the failure started at $T + 1.13$ sec (Figure 10). Movies also showed the failure developing during that period. The case pressure at 1.13 sec was 700 psig.

(C) Figure 10. Measured Strain (S044) of Skirt Overwrap

(C) The strain gage and extensometer at Location 1 indicated the time of failure. The strain gage dropped from 0.960 percent at 700 psig to 0.025 percent at 806 psig while the extensometer strain increased from 0.550 percent at 700 psig to 0.870 percent at 806 psig. The data show that the cracks reduced the overwrap strain and the loss of overwrap stiffness increased the case strain.

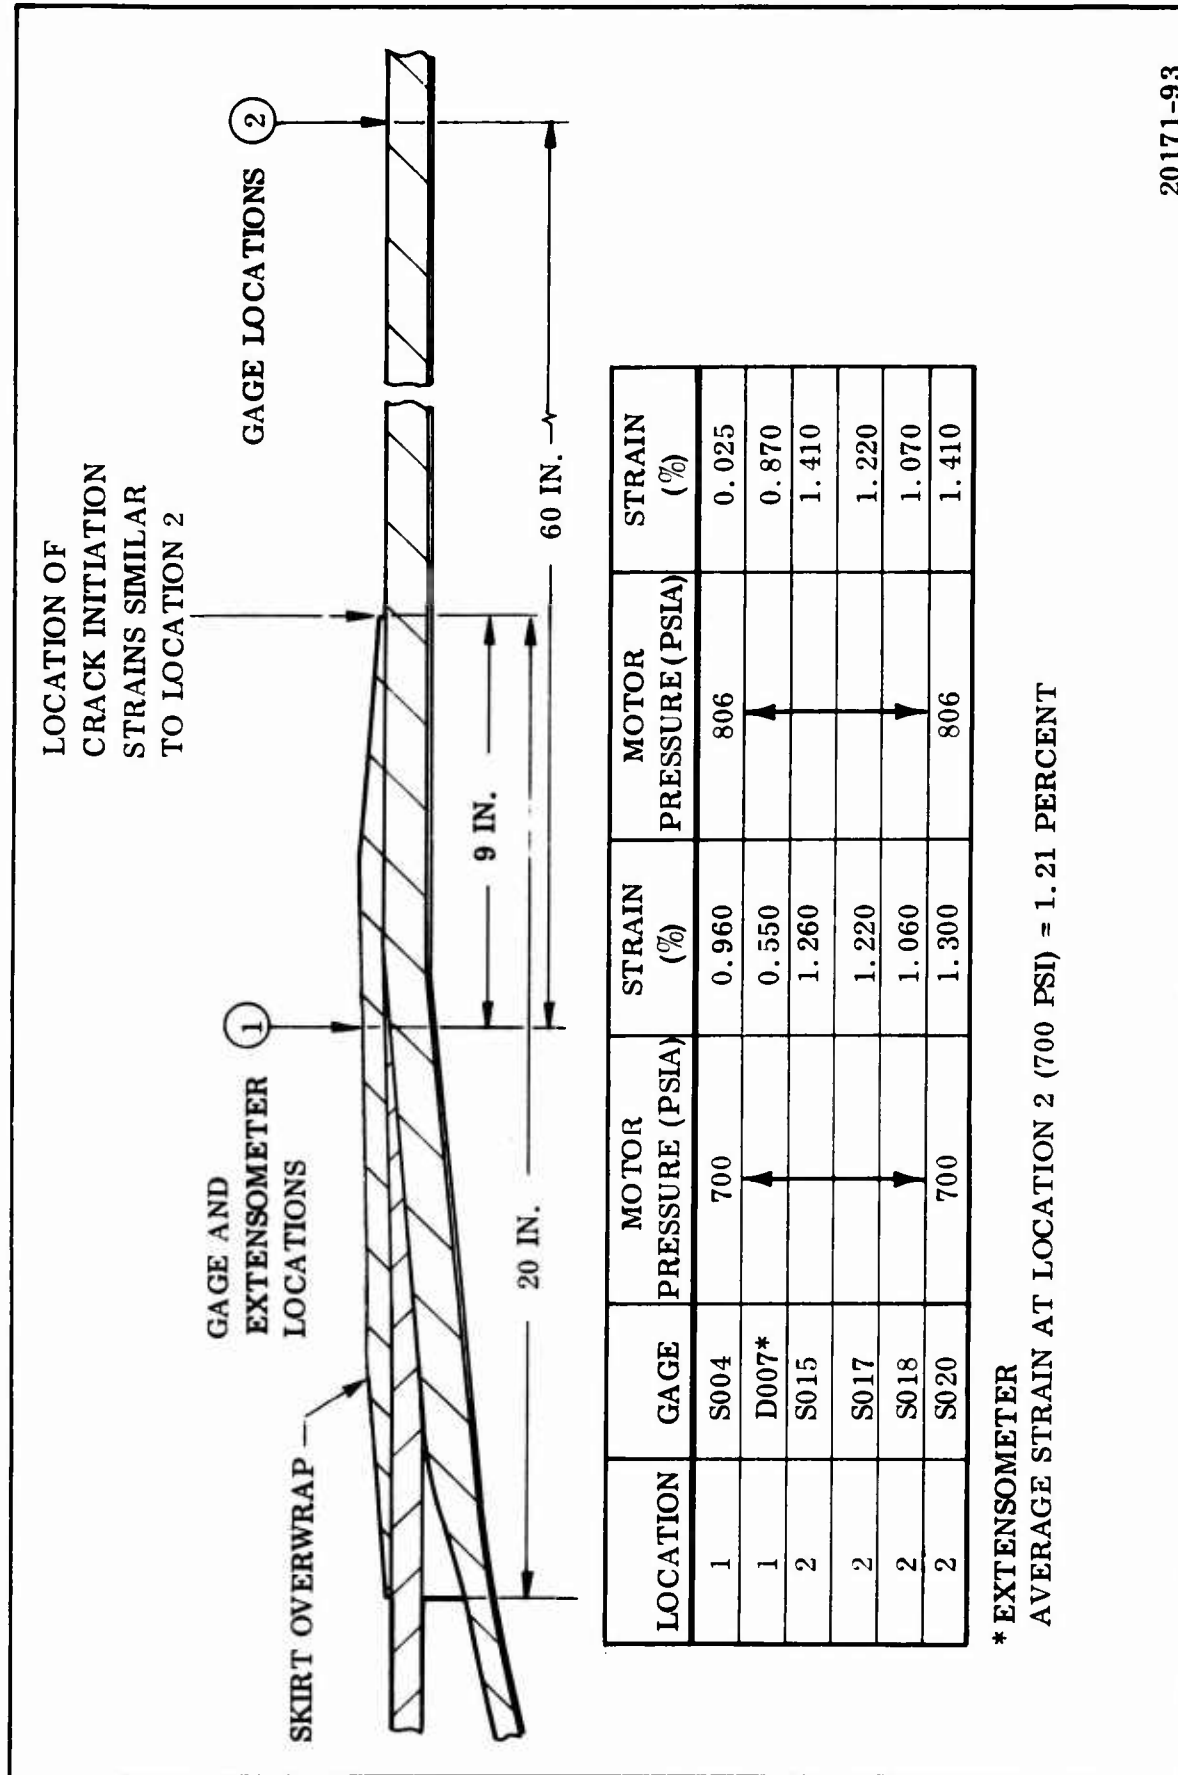
(C) The skirt overwrap extended 8 in. forward on the case, from the forward edge of the skirt (Figure 11). The hoop restraints of the dome and skirt decreased to zero in approximately 7 in. , and the strains at that point were similar to midcylinder strains (Location 2). The average strain at Location 2 (700 psi) was 1.21 percent. The minimum elongation capability of the glass composite overwrap was 1.05 percent. The induced strain at 700 psi was enough to initiate a crack at forward edge of the overwrap. Even though the induced strain was below 1.05 percent at the center of the overwrap, the crack progressed across the overwrap due to stress concentrations.

(C) Figure 11. Aft Skirt and Cylinder Strain Data

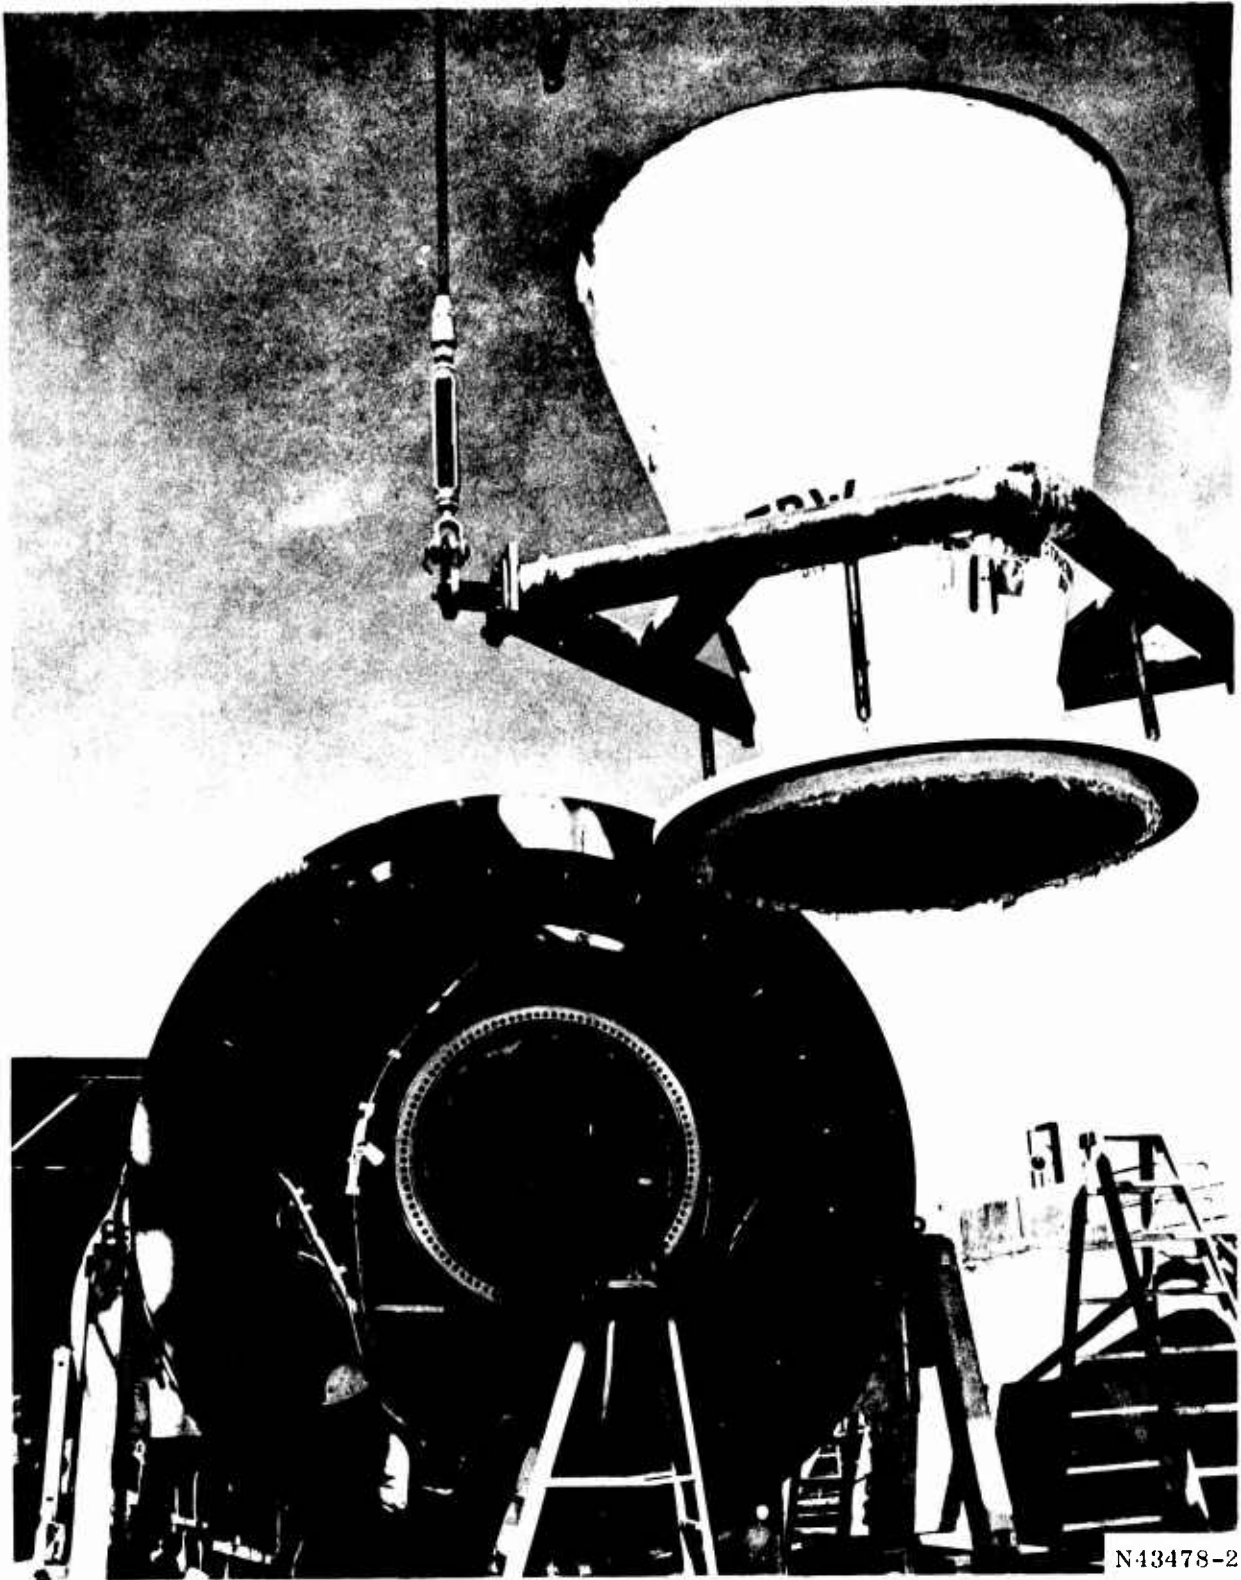
(U) Figure 26. Post-Test View of 156-8 Nozzle

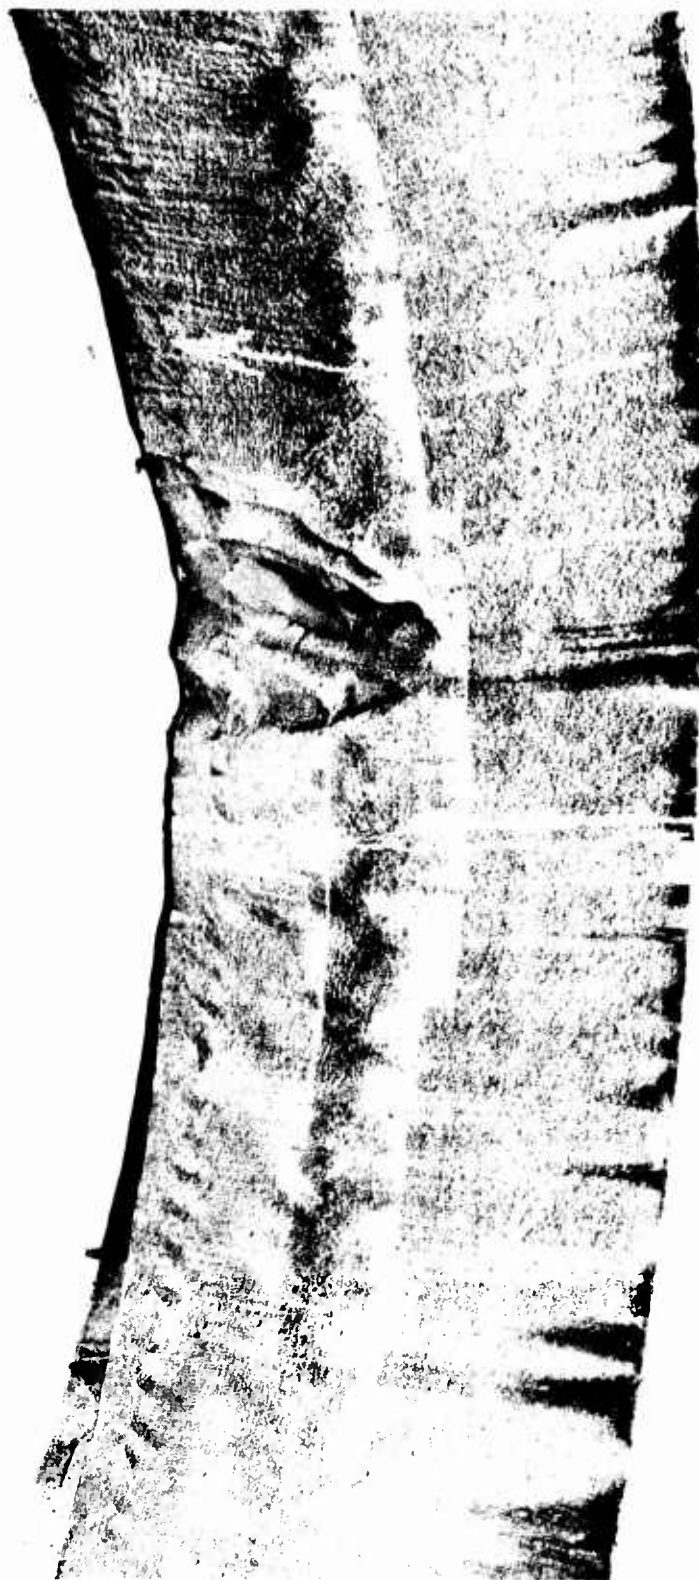
(C) c. Throat Section--In the throat section, the erosion pocket at approximately 100 deg actually consisted of three pockets washed together--starting just forward of the throat section, extending through it, and fading out just aft of the throat-exit cone interface. The center groove was 1.5 in. wide and 3.5 in. long with a maximum depth of 0.8 to 0.9 inch. The two outer grooves were approximately 1 in. wide, 3.5 in. long and 0.4 to 0.5 in. deep (Figure 28). At 280 deg, the pocket was 3 in. wide, 7.5 in. long, and 0.6 to 0.8 in. deep. At this point the inlet-throat interface joint appeared to have opened up, permitting gas to penetrate through the joint (Figure 31)

(U) Figure 28. Erosion Pockets in Throat Section, 100 Deg Location

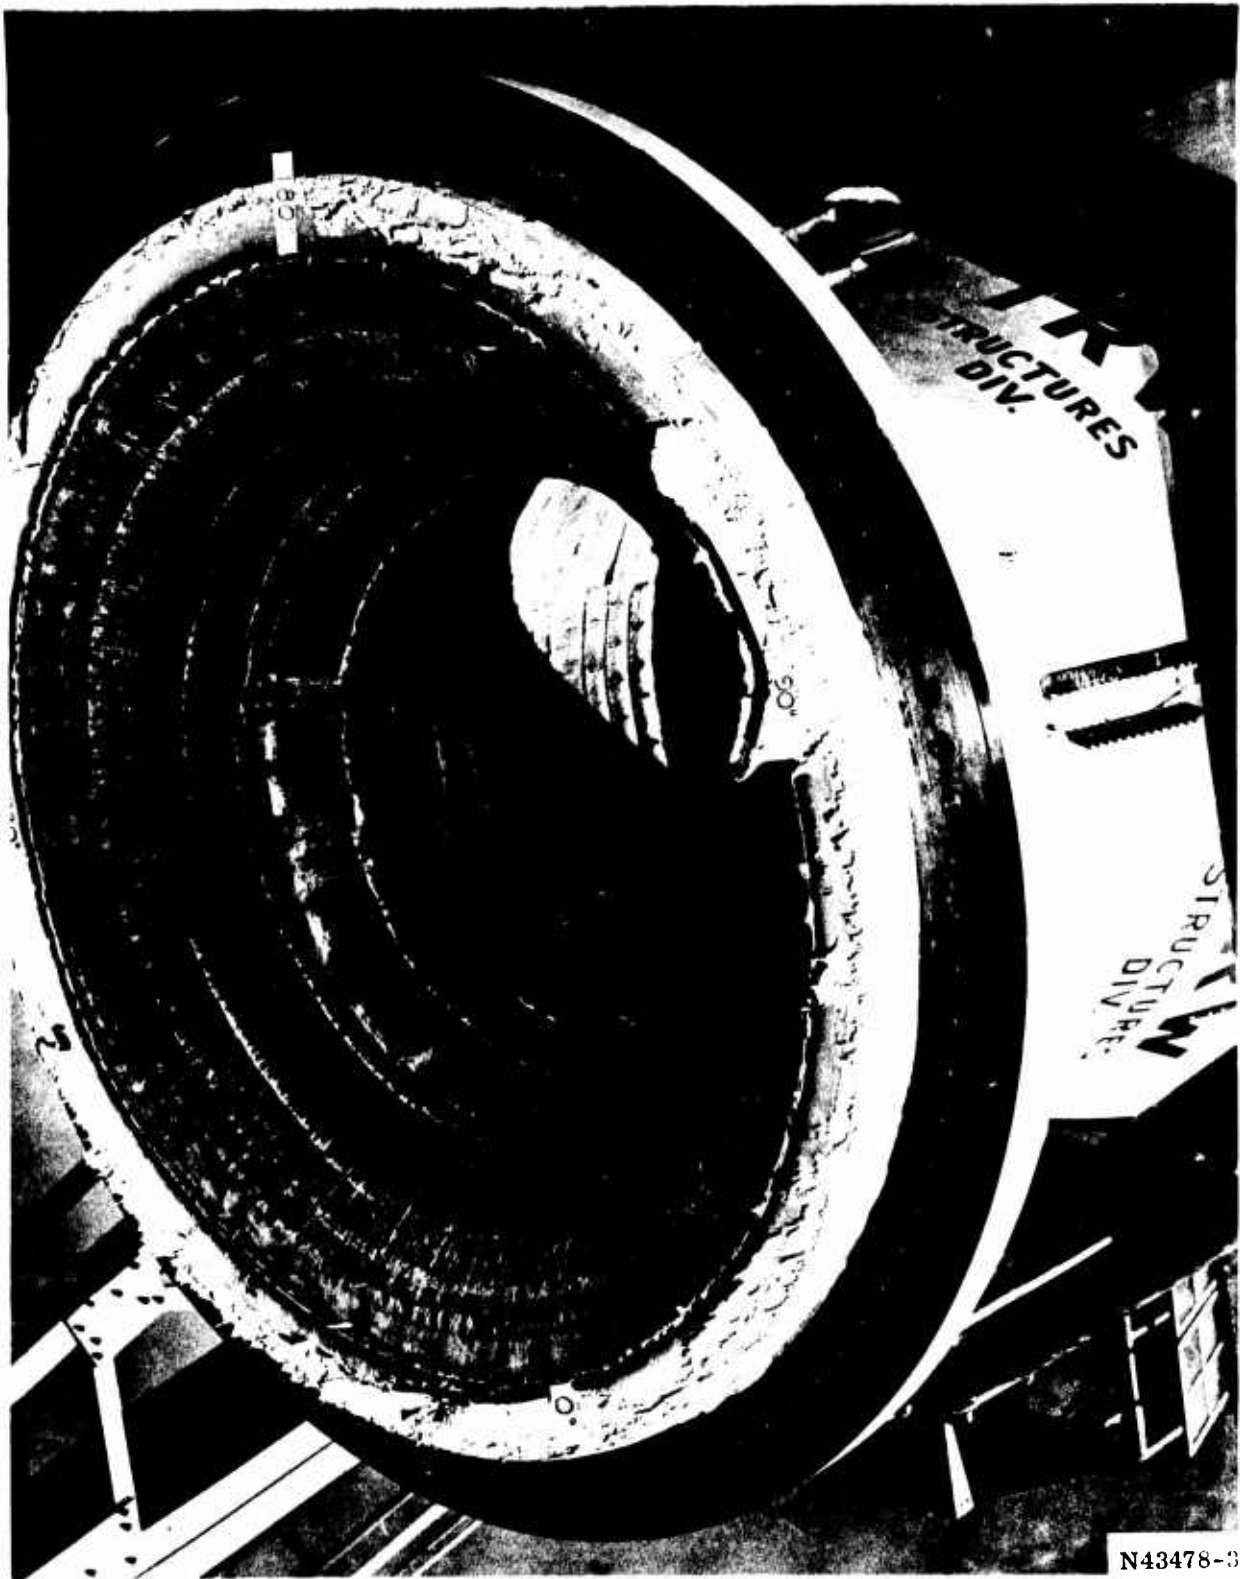
(C) b. Inlet Section--The inlet section experienced uniform erosion with some very thin delaminations running circumferentially. The delaminations extended in depth through the char layer terminating at the virgin material. An erosion pocket started approximately 3 in. forward of the inlet-throat section interface and extended downstream approximately 5.5 inches. This groove was 2 in. wide at its widest point and 0.4 in. deep at the deepest (Figure 30). A uniform char layer penetrated from 0.65 to 0.75 in. beyond the eroded surface.

(U) Figure 30. Inlet Section
